EVALUATION TEST REPORT		
Test Report No. 094/16/2014-2016/02/1791		18.03.2016
1.0	NAME AND ADDRESS OF THE CUSTOMER	Agpal Enterprises Plot No 037, MIDC, Tangar, Dist. Palghar Pin- 410302

2.0	CUSTOMER LETTER REF.	Email Dated 07 Feb 2016.
3.0	DESCRIPTION OF TEST COMPONENTS	1 no. Insulated Fire Door (Refer Drawing No. A21CH02005/13-14 dated 08.03.2015)

4.0	OBJECTIVE	To carry out Fire resistance test on Insulated Fire Door for 180 min duration as per IS 476 part 20 & 22 for insulation and integrity as per customer request.

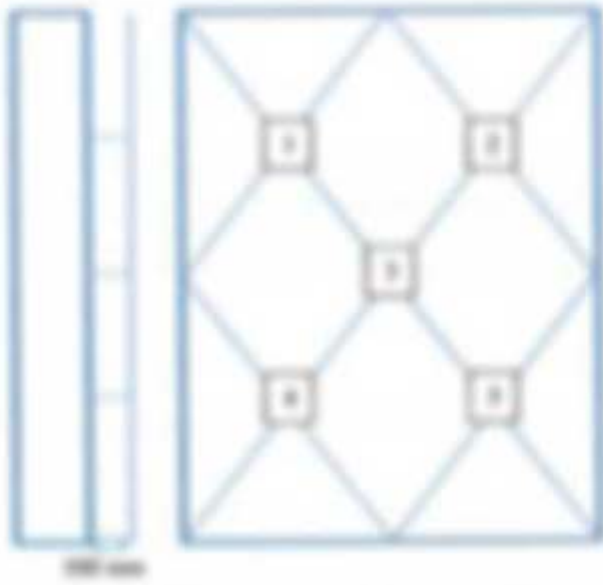
Fig. 1. Schematic of the Thermocouples mounted in the Furnace

7.3 The inside steel W type thermocouples were placed at a distance of 100 mm from the exposed side of the Door, one being at the center and the remaining at the corners of each square section. Fig. 1 shows schematic of the thermocouples inside the furnace (Refer Fig 1 & Photograph 1)

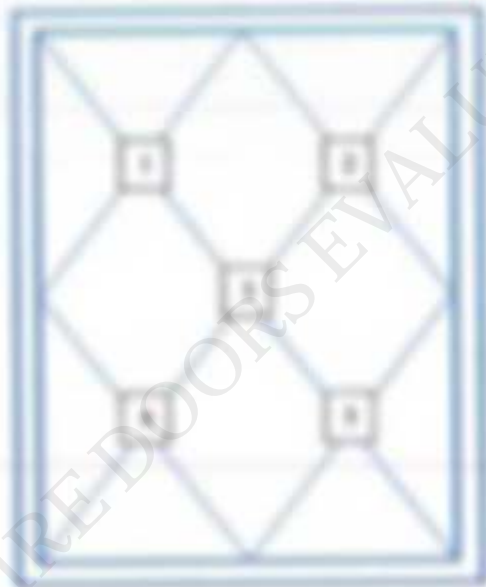
Fig. 2. Schematic of the Thermocouples mounted on the Door

7.4 The surface thermocouples of W type on the Un-exposed side of the Door, one being at the center of the door shutter, two at the center of each square section of the door shutter and three on the frame. Fig. 2 shows schematic of the thermocouples mounted on the furnace (Refer Fig 2 & Photograph 2)

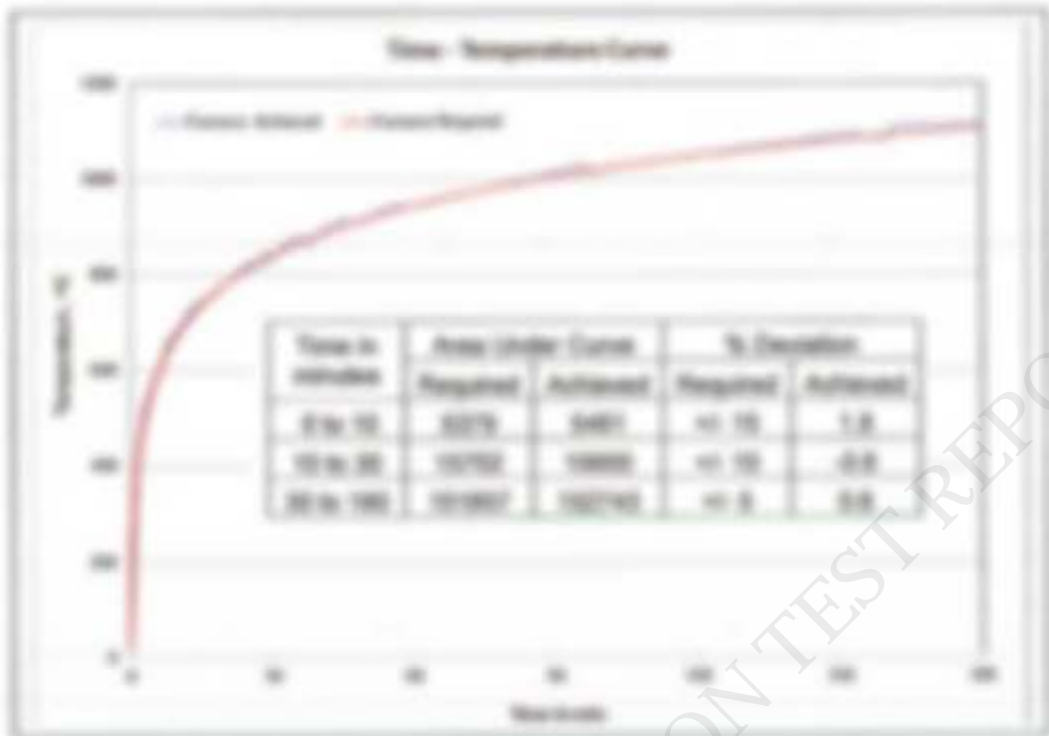
Fig 5. Time Temperature Curve of Furnace

Fig. 3 compares the requirement of the standard vs. achieved fire temperature plot for furnace.

7.5 Also make 05 Channel Temperature logger was used for recording the temperature variations of all the thermocouples. The furnace temperature was controlled according to the standard testing conditions specified in Clause 1.2 of IS 476 part 20.

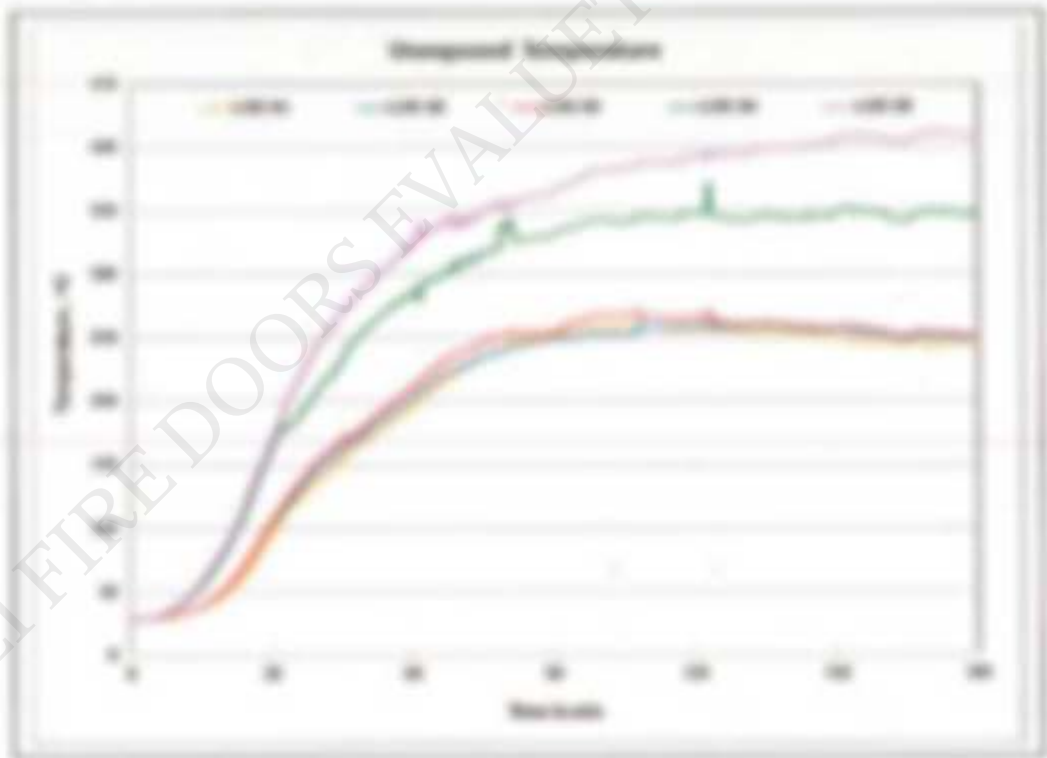
Fig 6. Time Temperature Curve for an exposed Side of Steel

- 6.1 Fig 4 shows the time temperature plot of the thermocouples recorded on the door.
- 6.2 The maximum temperature of the door recorded was 472 °C at LOC 2 and the maximum mean temperature recorded was 328 °C at the end of 180 minutes.
- 6.3 The ceiling gas did not ignite for the entire test duration of 180 minutes Refer Paragraph 4.
- 6.4 8 mm gas gauge did not penetrate throughout the test duration of 180 minutes.
- 6.5 25 mm gas gauge did not penetrate throughout the test duration of 180 minutes.
- 6.6 There was no sustained burning observed during the entire test duration of 180 min.
- 6.7 The door did not collapse during the entire test duration of 180 min.
- 6.8 The condition of the door on the compressed side and the expansion side after the test are shown in Paragraph 4 & 5 respectively.
- 6.9 **REMARKS:**
